# Condition assessment of a reinforced concrete jetty structure, its load capacity and suggested rehabilitation strategy

*Ahmad Shayan,\* Aimin Xu\* and Riahd Al-Mahaidi†*

*\* ARRB Transport Research, 500 Burwood Highway, Vermont South, Victoria, Australia*

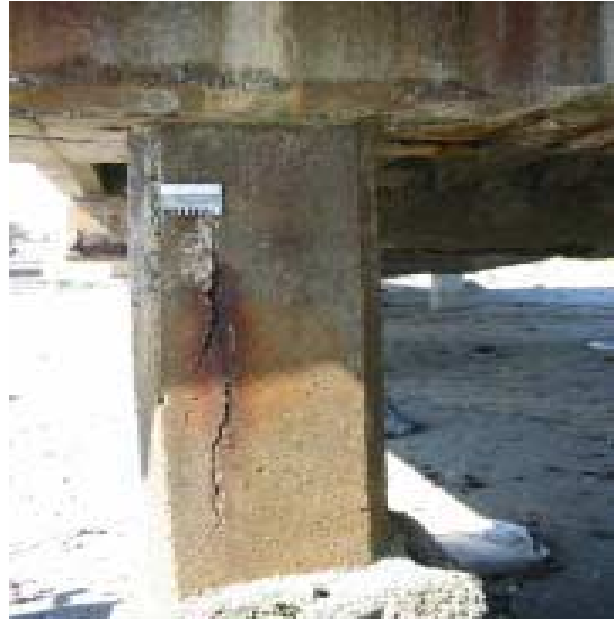
Many piles displayed large vertical cracks running parallel to the reinforcing bars at the corners of the piles (Figure 2). Rust stains are seen at some of the cracks and more at the junction of crosshead and pile. Delamination has occurred for some piles (Figure 3), where large cracks have developed at the two sides of one corner of the pile. In general, it appears that large cracks and delamination in piles mainly occur in bents near the shore. Approximate frequency of defects in the piles in the form of delamination, large cracks and rust staining, was 5%, 20% and 40%, respectively, of the total number of piles.

*Figure 2: Vertical cracking in pile caused by corrosion of steel bar*

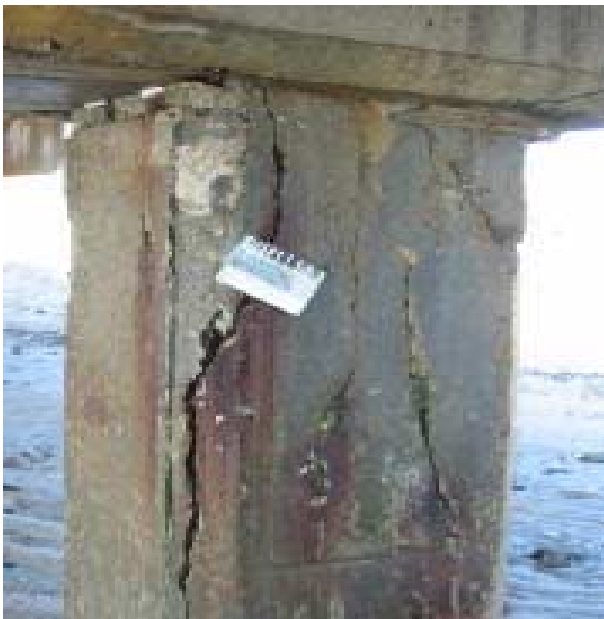
*Figure 3: Cracking and delamination in pile induced by corrosion*

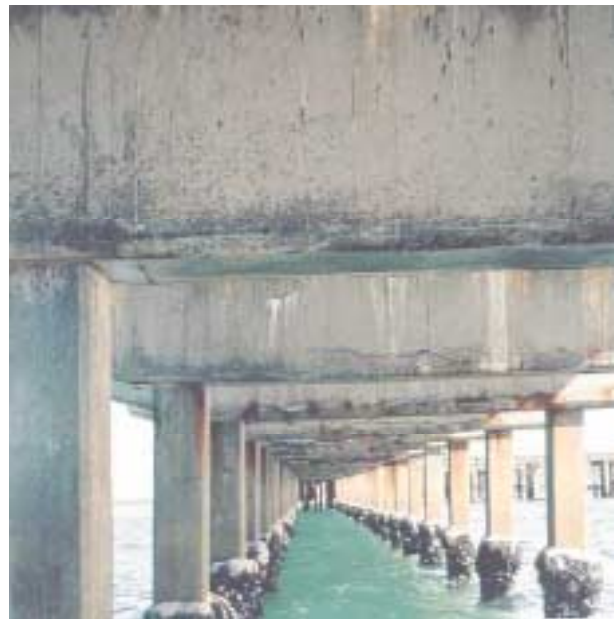
Reinforcement corrosion has occurred in most crossheads. Large cracking was present along the main reinforcing bars at the lower part of crossheads, about 100 mm from the soffit, and traverses the distance between the piles (Figure 4). Many crossheads have suffered delamination at this part, and large areas of spalling has occurred for some of the crossheads

*Figure 4: Cracking with rust stains appearing at lower part of crossheads*

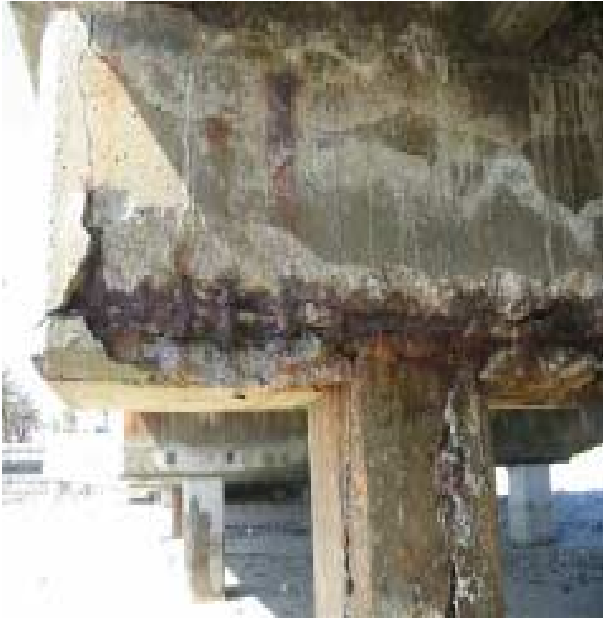
(Figure 5, 6). Significant loss of steel was noted in some of the stirrups in the spalled areas, and some stirrups appeared to have broken at the soffit. A significant loss of stirrup sectional area may affect the shear capacity of the crossheads. Honeycombing was also seen at the bottom edges of some crossheads (Figure 7). The steel section loss due to corrosion, in a location where the rusted reinforcement was exposed, was about 1-1.5 mm in depth, i.e. the diameter of the main steel bars (7/8 inch bar = 22.2 mm) was reduced to about 19-20 mm, after clearing the rust.

*Figure 5: Spalling of cover concrete at crosshead soffit*

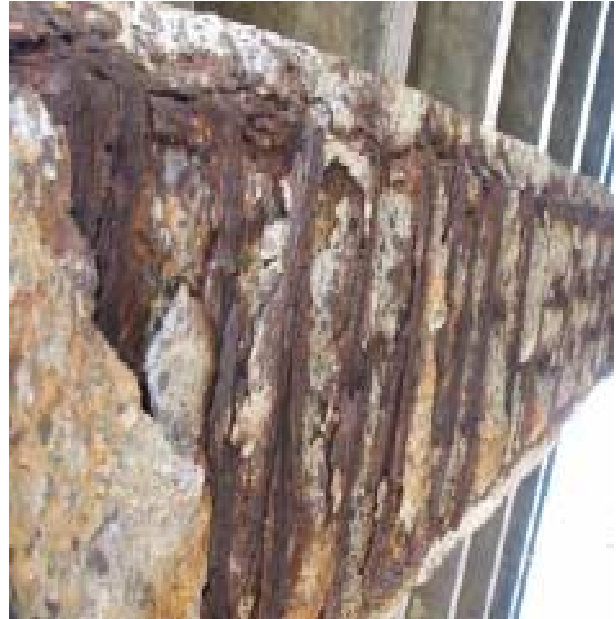
*Figure 6: Complete delamination of cover concrete at crosshead soffit*

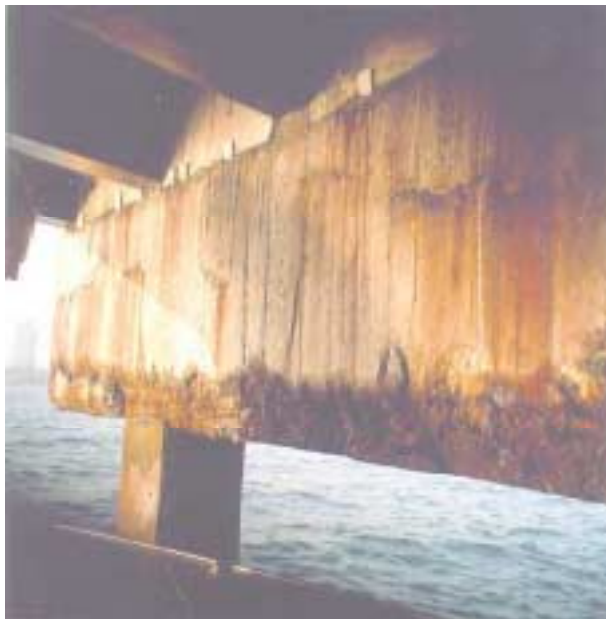
Corrosion of the upper main reinforcing bars has also caused cracking, but only in some of the crossheads. Scaling and efflorescence were common on crosshead surfaces, particularly at the crack sites.

*Figure 7: Cracking along the upper reinforcing bars and honeycombing at the bottom edge of crosshead*

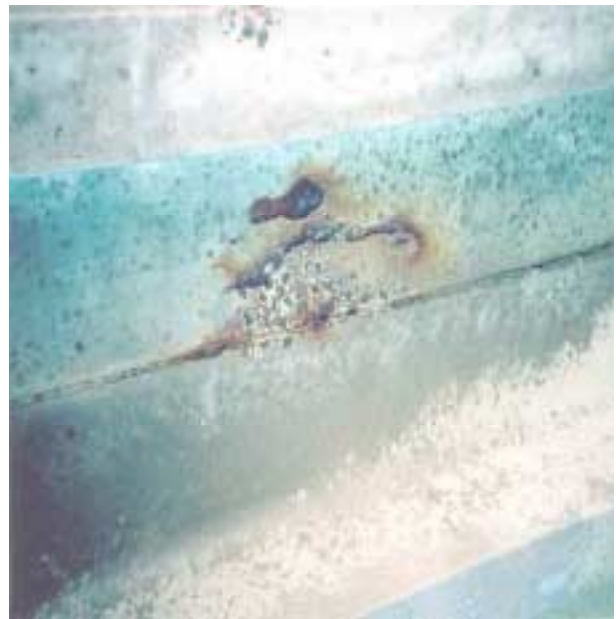
Some local reinforcement corrosion and small cracking have occurred at edges and corners of the deck planks (Figure 8), and on side surfaces of double T-beams. Slight scaling was evident on the top surface and soffit of the deck. Concrete coring at the top of deck exposed steel bars which showed very slight corrosion at 79 mm and 85 mm, and a light corrosion at 55 mm. At the side of a double-T plank, exposed prestressing strands (depth of 72 mm) showed no signs of corrosion.

*Figure 8: Localised corrosion at the edge of deck plank Bent 77*

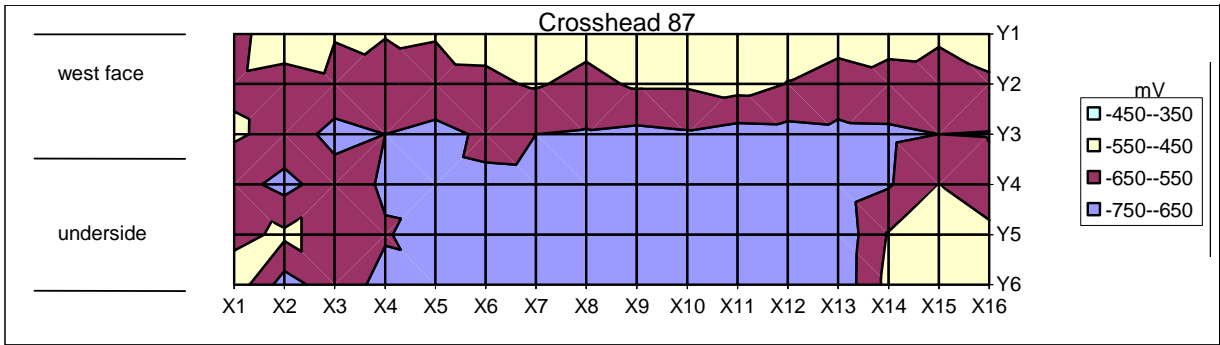
Half-cell potential was determined on 20 cm × 20 cm or 25 cm × 25 cm grids by the Ag-AgCl electrode. The results were converted to copper-copper sulfate electrode (CSE) at 25°C as required by the ASTM standard for reporting [CSE = (Ag/AgCl – 123) mV]. The temperature at the time of test was 10°C. The results are summarised in Table 1, and an example of the half-cell potential map produced for all the elements tested is presented in Figure 9.

In Zone 1, both piles have shown half-cell potential values more negative than -450 mV CSE, and a high gradient in areas adjacent to the crosshead, indicating corrosion activity. The crosshead also showed a high corrosion activity, indicated by its very negative potential (-450 to -750 mV CSE), particularly in areas near the piles. The deck soffit showed corrosion activity near the crosshead area.

The same pattern was noted in Zone 2, where results indicated a high corrosion activity in the crosshead, and isolated corrosion spots in the deck slab and piles.

**Figure 9: Half-cell potential map showing elements tested**

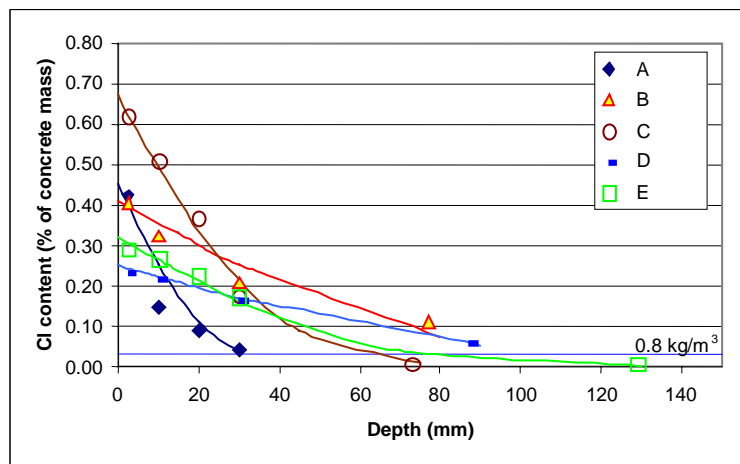
The chloride profiles of the elements tested are shown in Figure 10, where the data points and the fitted curves are both shown. Table 3 presents the values of the fitted parameters  $C_s$  and  $D$ . Based on these parameters, the trends for the ingress of the critical amount of chloride into concrete have been predicted and an example for a prestressed deck beam and a crosshead are presented in Figure 11.

The  $Cl^-$  content at the concrete surface was generally high, due to the marine environment of this structure. At the depth of reinforcement,  $Cl^-$  content was higher than or near the acceptable value of  $0.8 \text{ kg/m}^3$ . The higher values refer to the deck plank soffits, and crosshead underside where the cover concrete is thin, and the chloride content is three times higher than the acceptable level.

**Figure 10: Chloride profiles for the elements tested. Both experimental points and fitted curves are shown**

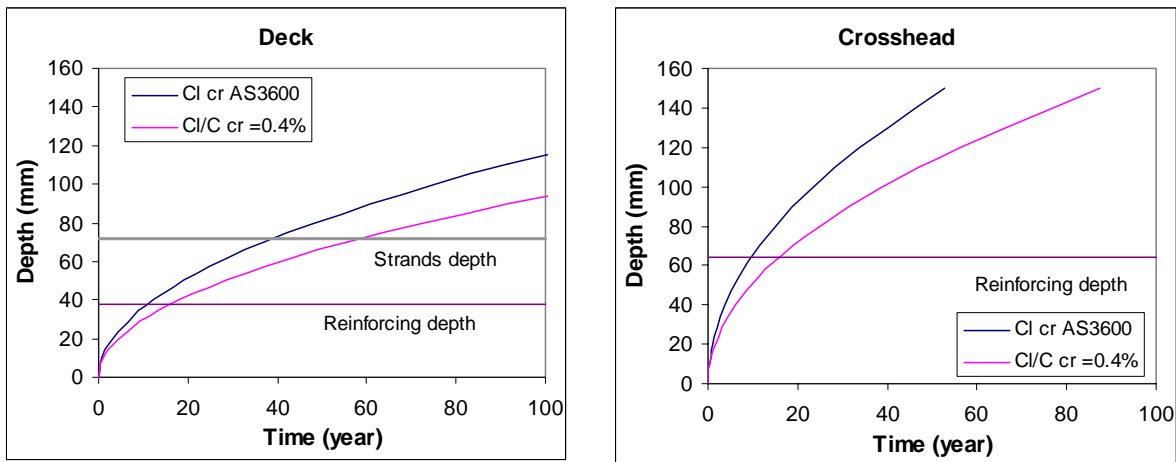
The predicted trends of chloride ingress (Figure 11) show that the critical chloride level for initiation of corrosion (0.4% by mass of cement) will reach the reinforcement level at around 16 years and 60 years for the crosshead and the deck respectively. Considering that the structure is 30 years old, the level in the crosshead was probably exceeded 14 years ago, and that in the deck will be reached in 30 years time.

**Figure 11: Prediction of chloride penetration into concrete for the deck and crosshead**

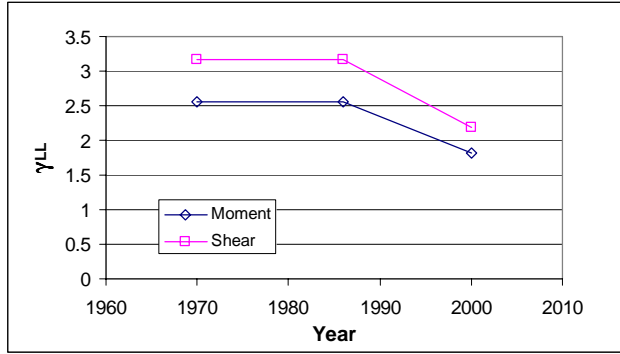
Based on the load distribution for single and double axle loading the  $\gamma_{LL}$  of crosshead, which is the worst deteriorated element of this structure was calculated and its values with time are plotted against time as shown in Figure 12. Alternatively, the trend can be presented in terms of axle load as shown in Figure 13 based on  $\gamma_{LL} = 1.5$ . Existing information from previous inspections were used to produce these graphs. The calculation for the present situation was based on our current results for strength of concrete and the rate of the reinforcing steel corrosion. It was also based on the current chloride profile, according to which the corrosion of reinforcing steel bars may have started in the late 1980s.

**Figure 12: The live load safety factors of deteriorated crosshead under 10 tonne double axle load**

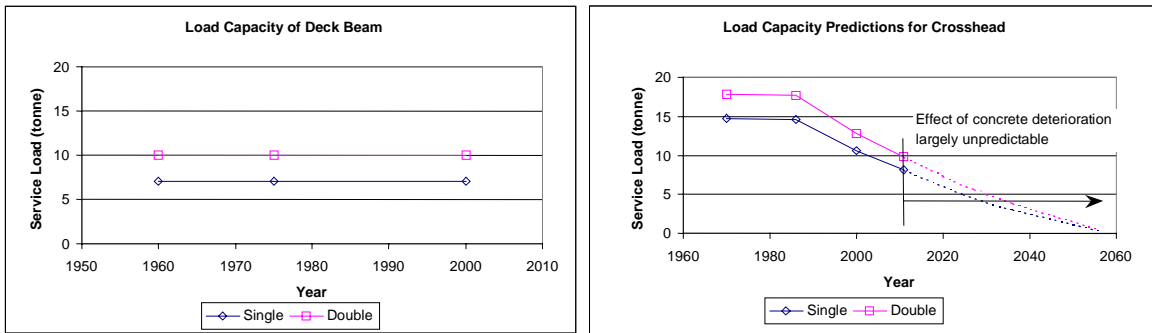
Figure 13 are load rating graphs for both the deck beams and the crossheads. Given the current condition of the crossheads and the anticipated future deterioration of these members, it is predicted that crossheads will become critical in the future while the condition of the deck beams will remain relatively stable. Hence, future life predictions are based on the condition of the crossheads as being critical. Of course, the structure should be re-inspected within 5 years to reassess the condition of its components and re-determine appropriate load ratings.

**Figure 13: The service load capacity of deck beams and crossheads**
